3D Imaging of Hydrogen Induced Cracking in Pipeline Steel

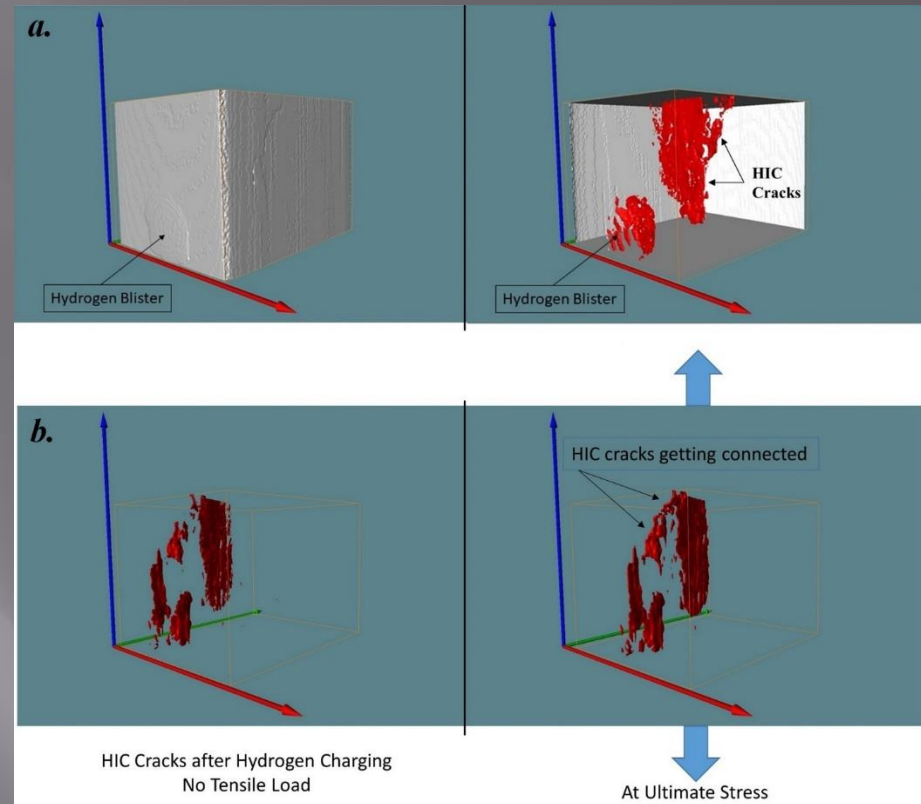
Environmental conditions of service affect the resistance of pipeline steels to failure, as a result, the applied stress which would be otherwise considered safe can be responsible for fracture due to hydrogen induced cracking (HIC). In Fig. 1-a hydrogen blister and HIC cracks were clearly visible in 3D imaging. The 3D imaging revealed that HIC cracks formed at the mid-thickness of the sample as well as at other planes of the sample parallel to the rolling direction which means HIC cracks can be formed anywhere in the sample depending on the favorable condition. The imaging also revealed that the HIC cracks that formed on different planes were connecting to each other when tensile stress was applied (Fig. 1-b). This indicated that HIC cracks were also involved in reducing the tensile strength of the steel as the connection of two cracks in two planes parallel to the loading direction made the crack orientation perpendicular to the loading direction and therefore becoming an additional factor contributing to tensile failure. Fig. 1-a also shows the surface blisters that were formed when cracks near the surface could not propagate further inside steel specimens.

Figure 1. 3D Imaging of Hydrogen Induced Cracking.

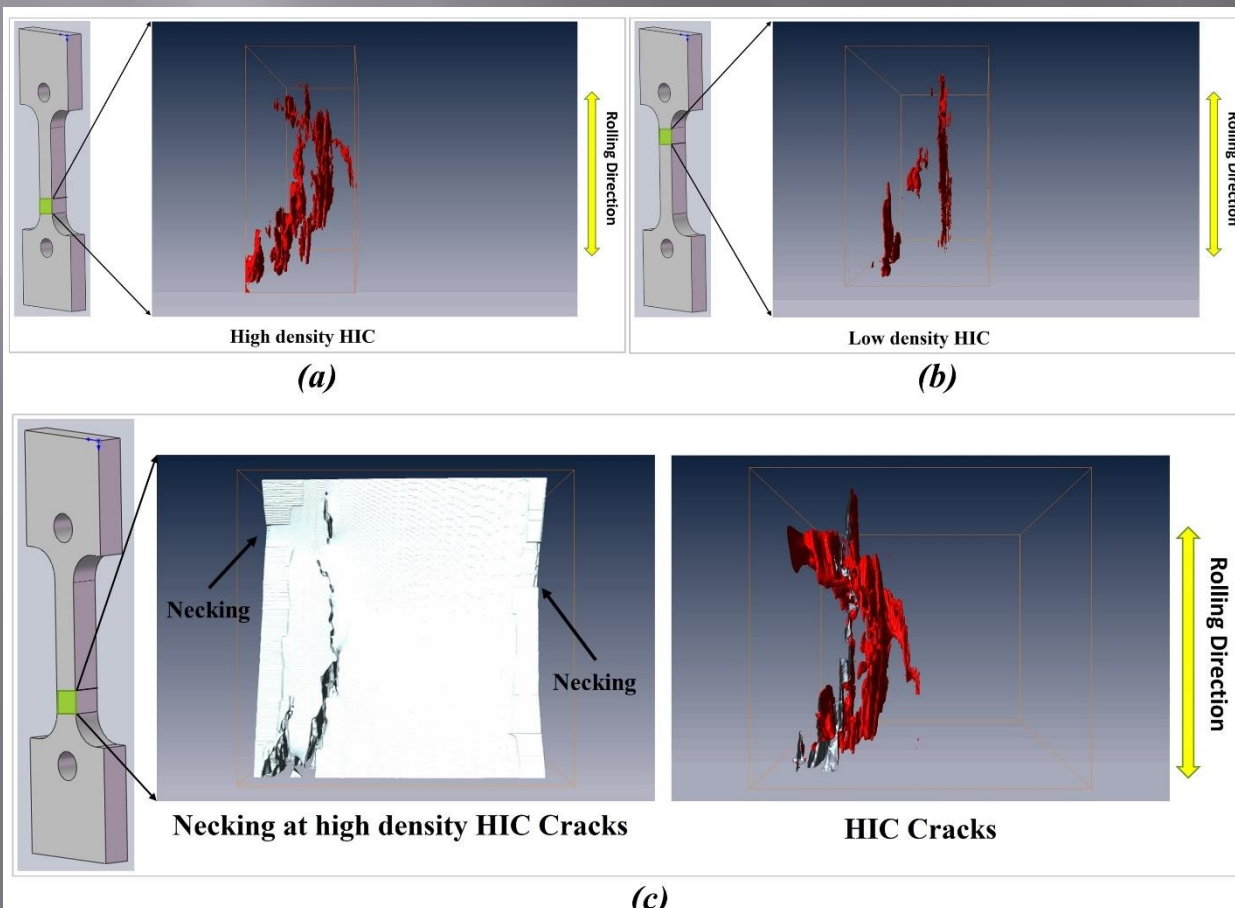
Figure 2. 3D Imaging of Tensile Failure Dependency on HIC Morphology.

Fig. 2 explains the dependency of hydrogen induced cracking morphology in tensile failure. Fig. 2-a and Fig. 2-b are two different position of the tensile sample which have different morphological HIC cracks in those regions. 3D imaging in Fig. 2-c revealed that the necking region had the high density of HIC cracks which act as stress raisers and get connected during failure and reduces the strength of the steel.
